Stream Habitat Assessment

Assessing stream and riparian conditions

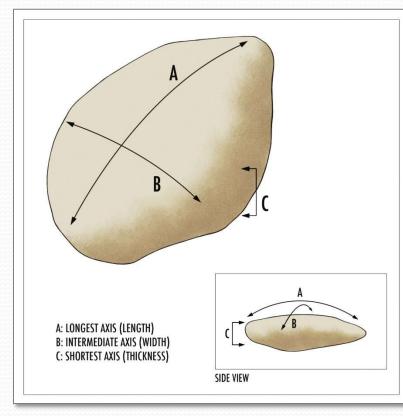
Pebble Count Survey

Wolman pebble cou			
Size class	Dimension	In wetted	Out wetted
Silt/Clay	0—1 mm		
Sand	1.1—2.5 mm	1#1	111
Very fine pebble	2.51—6 mm		<u> </u>
Pebble	6.1—15 mm	III	
Coarse pebble	15.1—31 mm	111T III	
Very coarse pebble	31.1—64 mm	WH W II	
Small cobble	64.1—128 mm	1111	
Large cobble	128.1—256 mm		
Small boulder	256.1—512 mm		
Medium boulder	512.1—1024 mm		
Large boulder	1024 mm and larger		
TOTAL
